State Route 88 Apache Trail

Interim Road Repair

Fish Creek Overlook at MP222 to Reavis Trailhead at MP 229.6

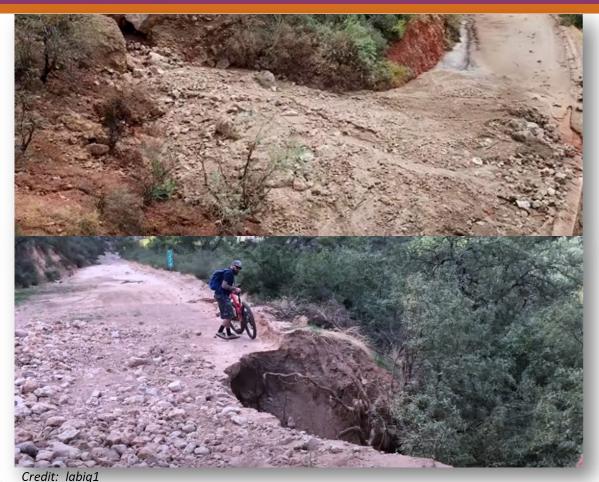
September 23, 2019 Flash floods resulting from Hurricane Lorena brought down ash, debris, and sediment into the canyon

...triggering massive erosion

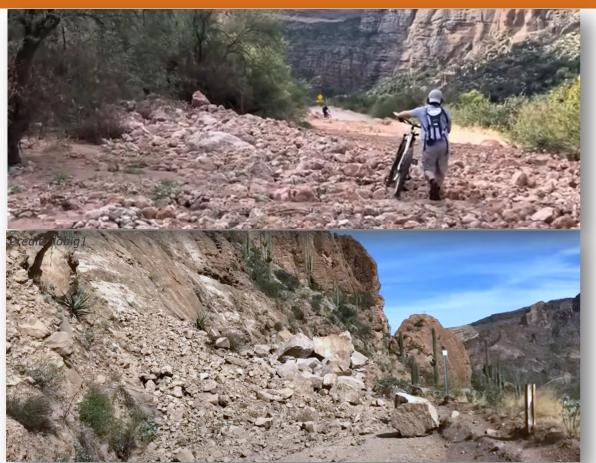
September 23, 2019 Flash floods resulting from Hurricane Lorena brought down ash, debris, and sediment into the canyon

...triggering massive erosion

...and rock slides

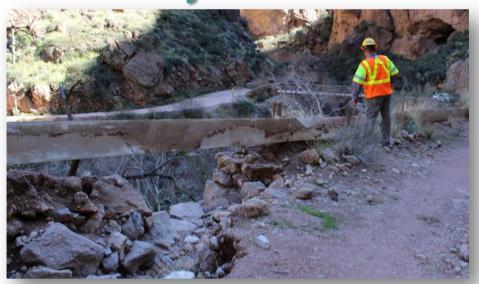
Eroded roadway edges

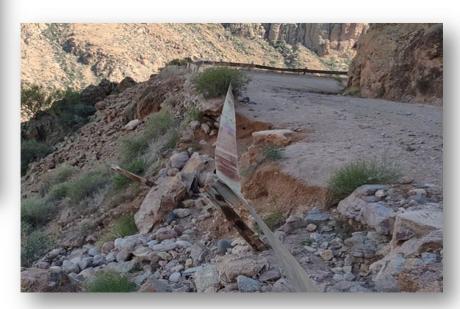
Debris and sediment

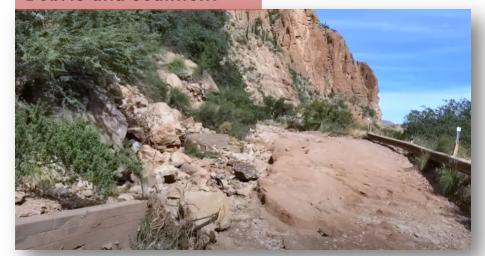
Heavy rilling

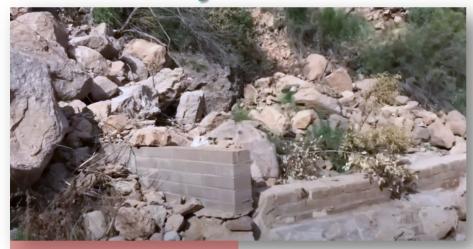
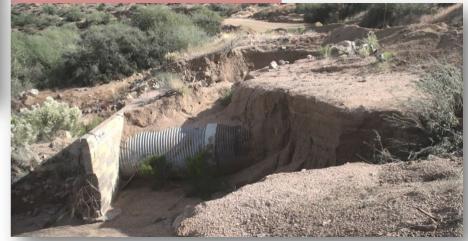
Buried culvert inlets

Clogged damaged culverts

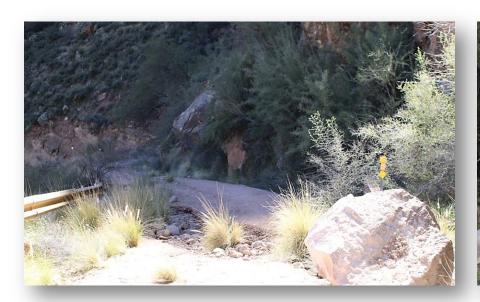
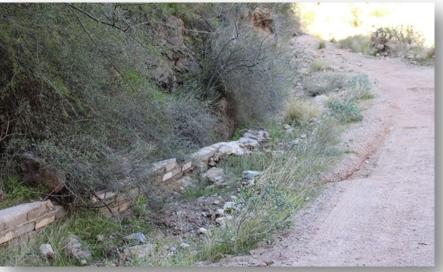
Overgrown vegetation
