State Route 88 Apache Trail

Interim Road Repair

Fish Creek Overlook at MP222 to Reavis Trailhead at MP 229.6

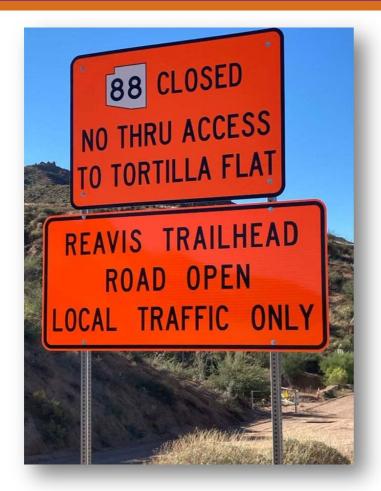
September 23, 2019 Flash floods resulting from Hurricane Lorena brought down ash, debris, and sediment into the canyon

...triggering massive erosion

...and rock slides

SR88 closed due to the damage.

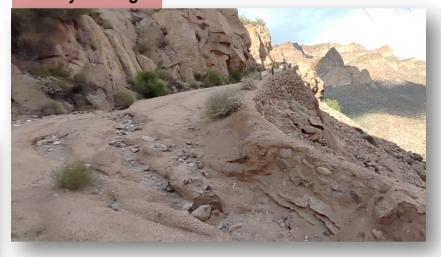
Buried culvert inlets

Clogged damaged culverts

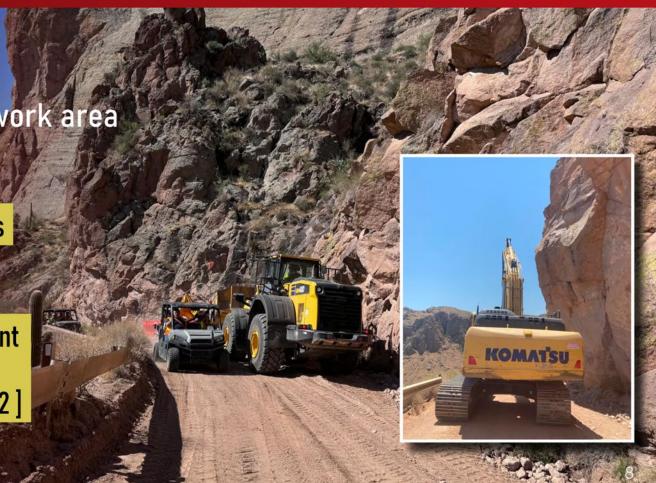
Extremely narrow work area

As little as 12 feet wide

Not enough room to pass

Used side-by-sides

Stop and stage equipment in order to pass [narrow work zones 1 + 2]

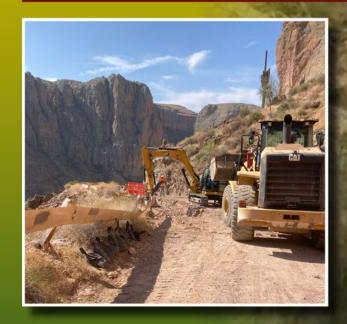
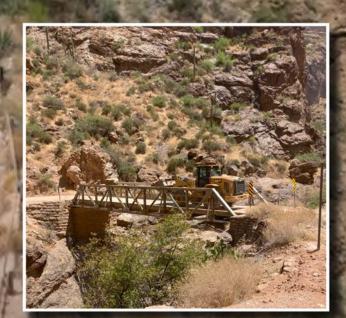
BREAKING BOULDERS

All material hauled with loaders
